Housing Facilities Construction with Accessories and Architecture Construction of Mills in Anamorava over the Centuries

Riza Fazliu

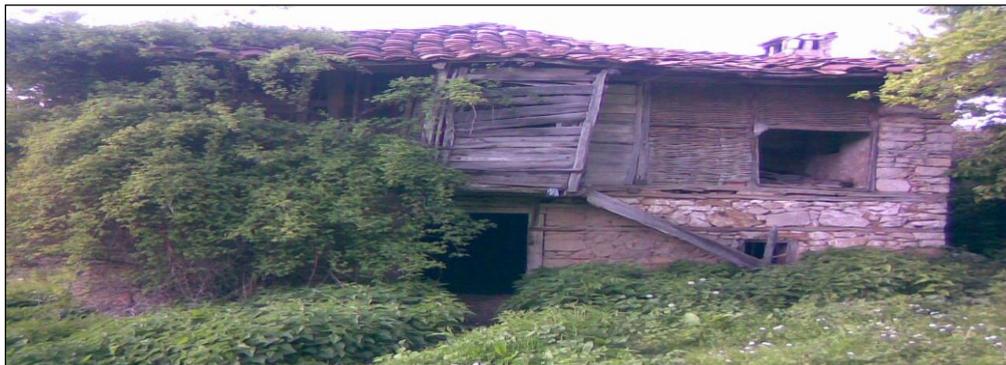
On the right there was the men's room which had a fireplace in the middle of the room and shelves for the introduction of moldings and other necessary things for guests and window overlooking the main road which served also for orientation and observation towers.

This type of objects, which otherwise is called twin home, was quite dispersed on the level of the Morava region. The houses also consisted of two or three rooms, which had a special destination. Characteristic of this type of housing was that from its front side can be seen the number of rooms. The architecture of this kind was very interesting, so the impact of this type of houses was spread in some neighboring countries, such as Serbia, Bulgaria etc. Houses of this type continued to be built for centuries, while building material and architectural experience were being improved. Morava houses contained in themselves the heating room and another one, whereas richer families also made larger guest rooms. Depending on the increase of the family there could be added an extra room. This way they were called double houses. Besides this type of houses there were also houses of other Morava type. These houses were identical to those of the previous type, but the difference lay in its annex which was dedicated to cattle, it means the increased part for cattle. Construction of such type was widespread especially in the upper Morava and in the surrounding areas. Characteristic of this type was an extra part dedicated to cattle; however all of them were similar to bungalow. Upper Morava as the initiator of the type of house, or colonial house, was full of houses of this type. One floor houses otherwise were called Vardar home. The architecture of this type of housing was similar type of Moravian houses but the next characteristic was that cattle were placed in the ground floor. A typical example of such is undoubtedly the house of Haji Ahmet's house in the village of Goden, the municipality of Viti, which, as shown by local residents is built between 1880-1900², ie during the Ottoman period and luckily this building has been conserved up to nowadays. We visited it to find that this object was a very rare building which in itself carries much precious architectural value and as such should be preserved by institutions as part of the cultural heritage of Anamorava. The building until some years ago was in excellent condition but now it is seriously threatened by weather condition, particularly after 2010. As a result of the harsh winter of that year the house's roof collapsed. During the visit there were made some photos and taken measurements of the building which will be presented in this paper. It has dimensions of 800X800 cm. Its ground floor served for keeping the livestock and its entrance hooked up in the middle of the house with dimensions of about 160x120 cm. On the right side of the door of the ground floor there were floor stairs. Above the staircase there was located corridor with wooden terrasa (divane) as it was called in the jargon of that time, certainly influenced by the Ottoman language and culture, with dimensions of about 400X200 cm. In the right part of terrace there is a small part of the house, physically separated by walls between which served as the site for placement of different things related to the men's room. Their dimensions were about 300x200 cm and characteristic of this part of the house is the outside forefront which is interwoven with twigs painted in step, ie, mud from the interior which gives the house in question features a unique dwelling place with all construction elements which were characteristics of this area. There are two large rooms in these houses; one men's room with dimensions about 500X 400cm and 500X300 cm.

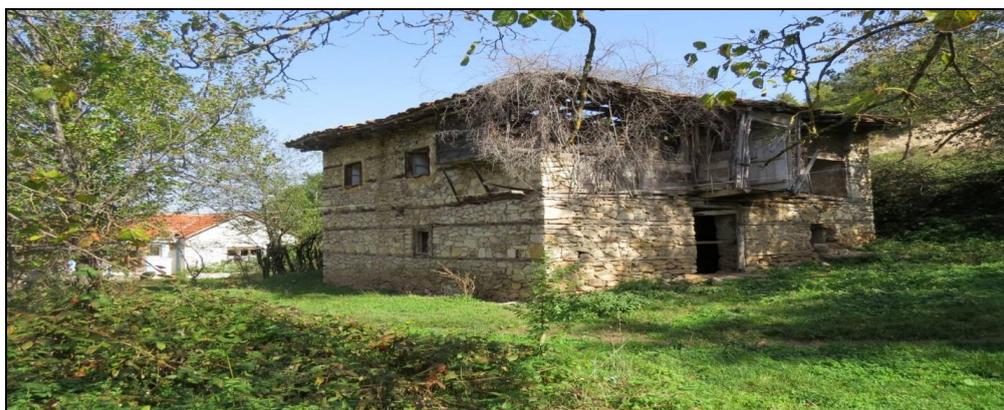
Another smaller room for women and children serve as a cite for resting during the day when there were guests, also it served as a sleeping place when there were no guests in the house. Next I would like to present the physical condition of the facility in this relation because the picture presented earlier is made in the summer of 2010. As stated above, the winter of that year was severe and snow damaged the roof of that house. In the present situation this rare object of cultural heritage is being threatened by collapse of the roof. I would like my work to serve as an appeal to local institutions of culture centre to repair the roof of this house, because with a little investment this building would be preserved for future generations. This picture is made now, i.e. here it shows the current state of the object in which the roof is covered with dry twigs and now damaged by snow.
